## Machine Condition Report

**Location:** BUILDING 121 AIR COMPRESSORS  
**Equipment:** COM1/121 COMPRESSOR #1, BLDG121

**Diagnosis:** Misaligned across coupling

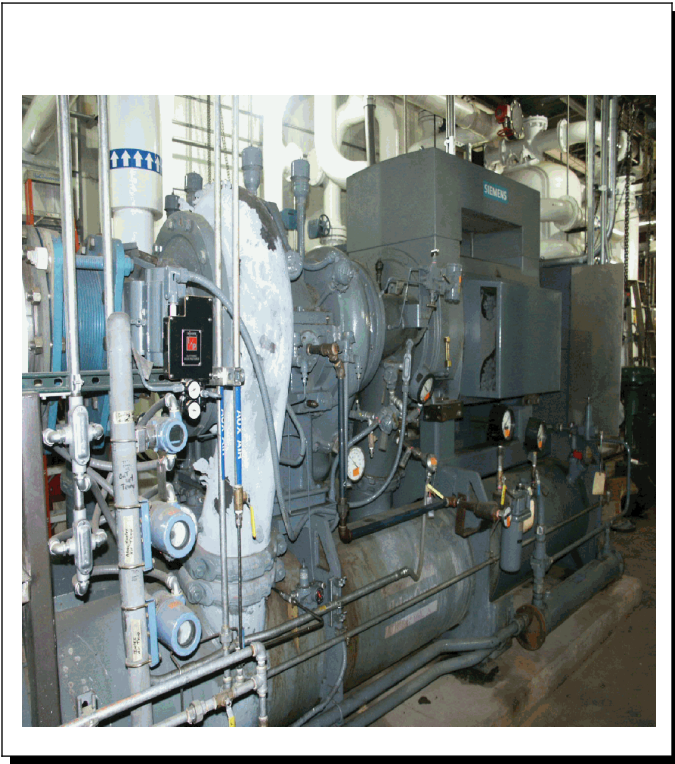
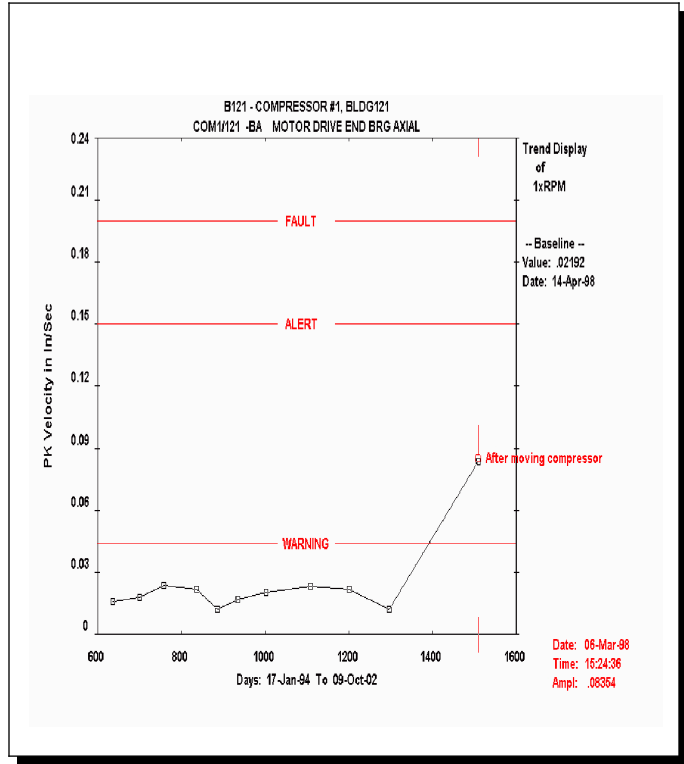
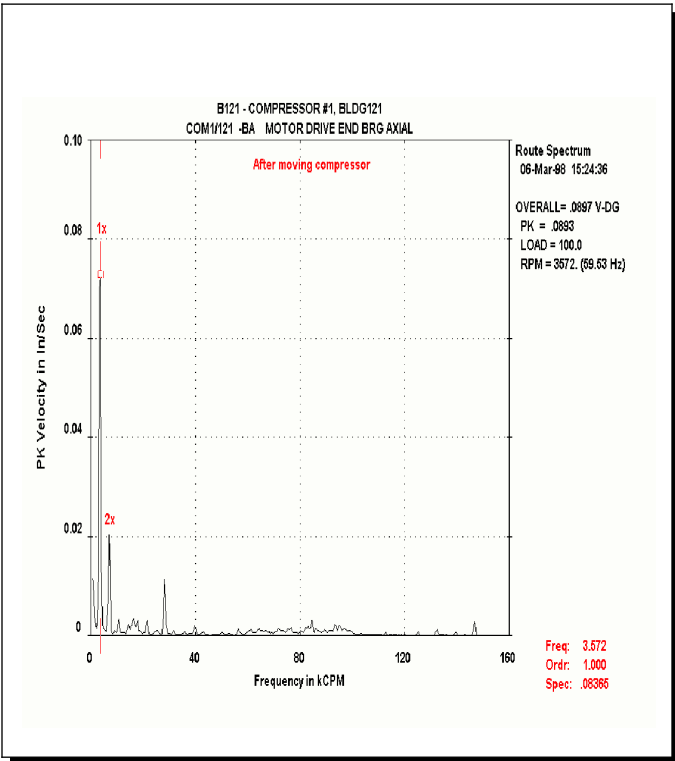
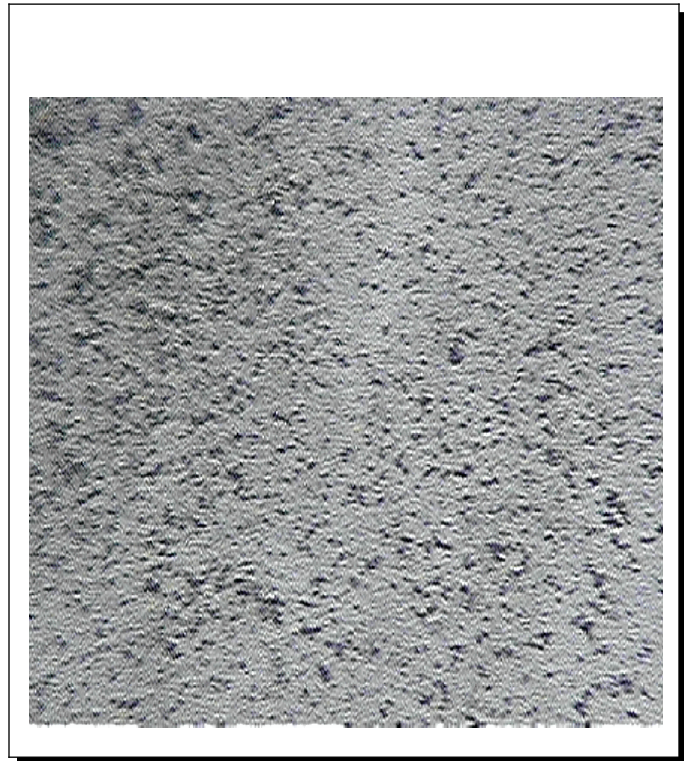
**Explanation & Recommended Action:** 3-17-98 This is the first measurement since the compressor and motor were moved to this building. The axial vibration amplitude on the motor has increased. The oil sample from the drive end motor sleeve bearing has a large number of fine non-ferrous particles (see microscope photo).

4-14-98 Hot alignment was checked with a laser alignment system. Alignment readings indicated that the motor was setting approximately .030" high at the drive end and .045" high at the non-drive end. Soft foot was found between the skid and concrete floor at the Southwest corner and both mid-span supports. No soft foot was found on the motor feet.

The axial float in the coupling was insufficient to set the motor on magnetic center. This indicates that the coupling was installed without setting the motor rotor on magnet center. Inspection of the drive end motor bearing indicated significant wear on the thrust surface (see photo). This was caused by the improper coupling axial position.

Recommend checking coupling alignment (hot) and inspecting the motor bearing.

The motor bearing was replaced (on-site) since no shaft damage had occurred. The compressor skid was shimmed to the floor to remove the soft foot. The coupling was centered in the axial float with the motor on magnet center and the vertical alignment was adjusted for the measured thermal rise.
